CORNER RECORDDocument Number CR 7536City of UNINCORPORATEDCounty of ALAMEDA, CaliforniaBrief Legal Description RAILROAD SPIKE MONUMENT LOCATED WITHIN MINES ROAD

**CORNER RECORD**

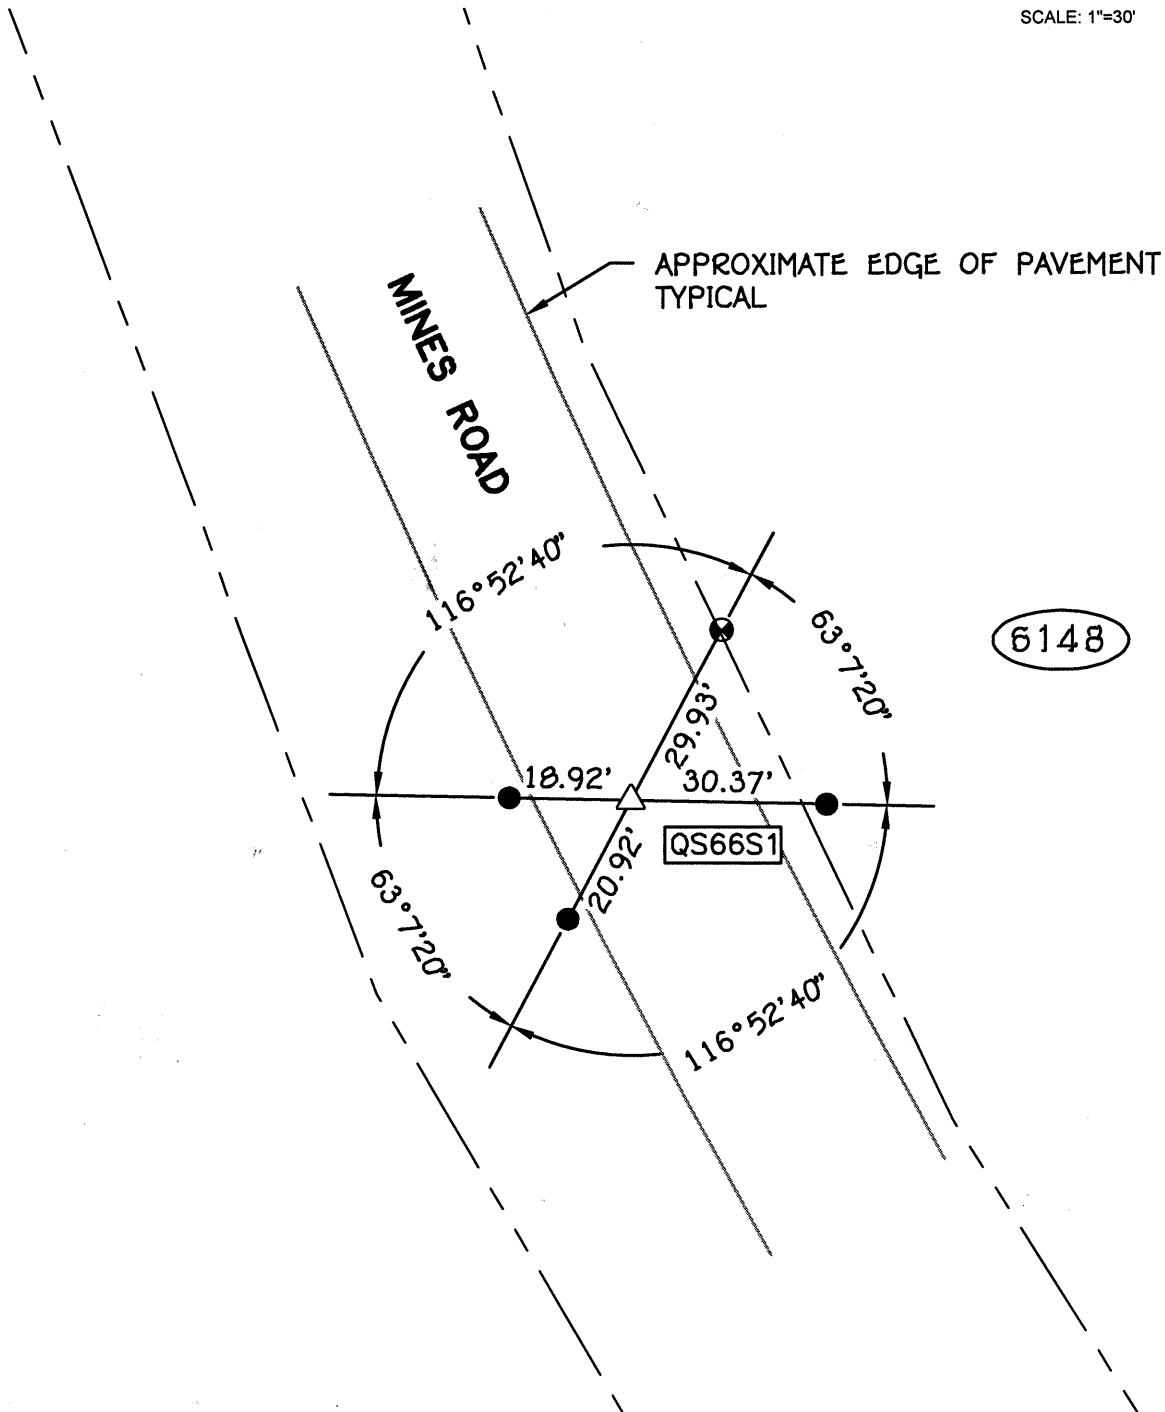
FOUND AND SET POINTS AS SHOWN ON PAGE 2.

THESE TIES ARE FOR THE PURPOSE OF PERPETUATING THE FOUND MONUMENTATION.

Identification and type of corner found: Evidence used to identify or procedure used to establish or reestablish the corner:
FOUND RAILROAD SPIKE WITH CHISELED "X" LOCATED WITHIN MINES ROAD.
